**Preservation Issues Subcommittee, Boulevard Neighborhood Association
Comments for Historic Preservation Commission, June 20, 2007**

Item # 2 New construction, 150 Cohen Street

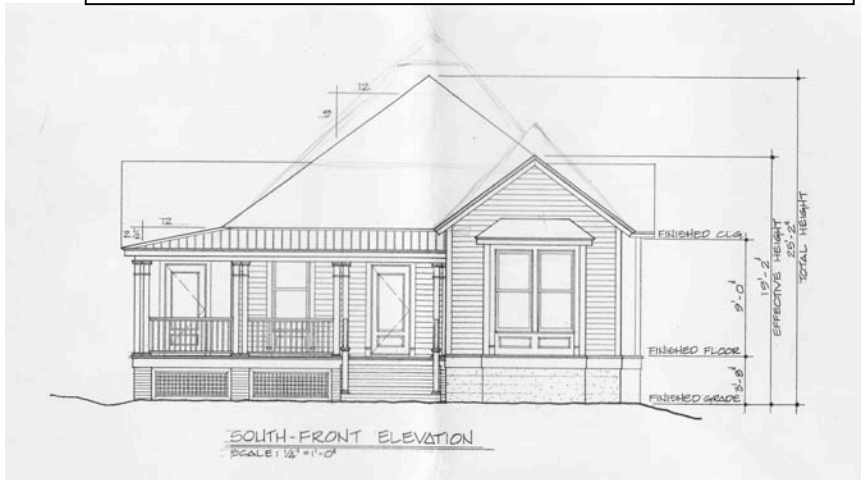
Proposed design with penciled changes on roof line

As we looked at the design, the first comment was that “something does not look right” about the front gable. After viewing contributing structures in the Boulevard Historic District, we believe the roof pitch on the gable and the main roof need to be adjusted and made closer to a 45% angle. Houses of similar design (see photos below) have steeper roofs which cause the peak of the gable to rise above the plane of the main roof. The inclusion of a properly placed decorative vent in the gable may also enhance the look of the front elevation of the house.

We also think the garage needs to be shorter than the gable but should have a steeper roof than the current plans indicate.
